Debugging a Mixed Signal Design with a Tektronix Mixed Signal Oscilloscope

Introduction

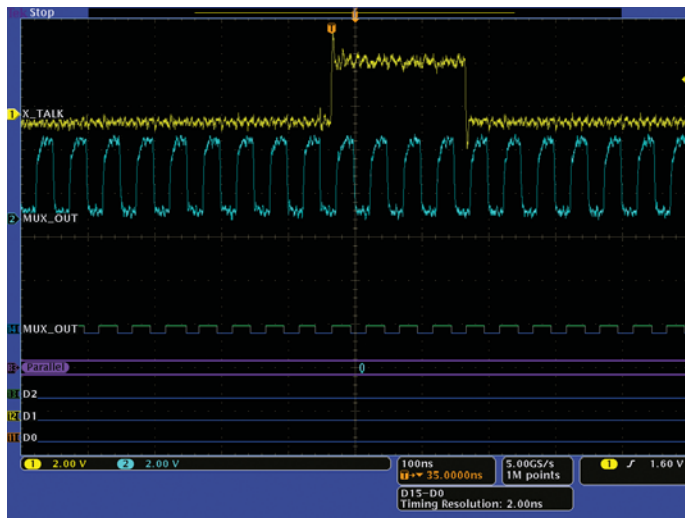
Figure 9. The PCB modification removes the crosstalk.

After spending some time to reroute the offending signal on the circuit board, the engineer configured the MSO Series oscilloscope to trigger on CH1. Figure 9 shows that the MSO Series triggered on the CH1 transition, but does not show a glitch on the MUX_OUT signal. Since the MUX_OUT signal did not have a glitch present, the parallel bus did not

produce an error condition. The circuit board modification removed the crosstalk, and allowed the embedded design engineer to complete his system evaluation.
